# Performance of wastewater treatment eco-technologies applied in Fijian villages

*Votua, Bavu and Namaqumaqua villages (Viti Levu, Fiji), Rustic Pathways (Fiji), Rotary Pacific Water for Life Foundation, Nadroga-Navosa and Serua Provincial Councils, Water and Sewerage Department of the Fijian Ministry of Infrastructure and Meteorological Services, Fijian Ministry of Health and Medical Services, Fiji Board of Health, and the New Zealand Aid Programme of the Ministry of Foreign Affairs and Trade*

*March 2021*

NIWA CLIENT REPORT No: 2020249HN  
Report date: March 2021  
NIWA Project: MFA19201

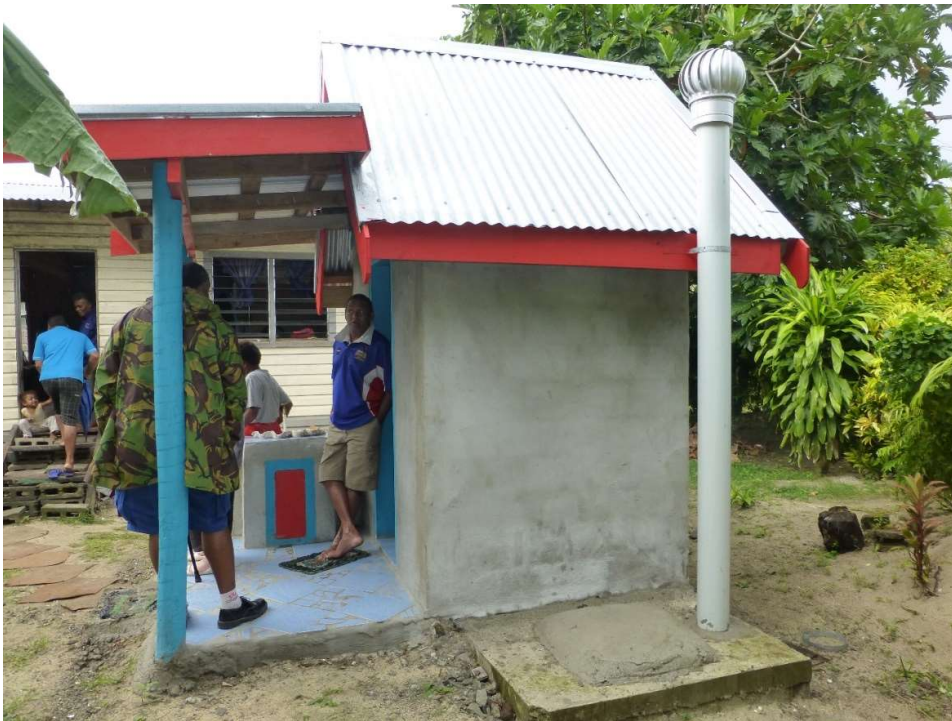
**Figure 2-3:** ecoVIP2 pit latrine showing vent pipe. Note the pipe has not yet been painted black, necessary to aid convective ventilation.

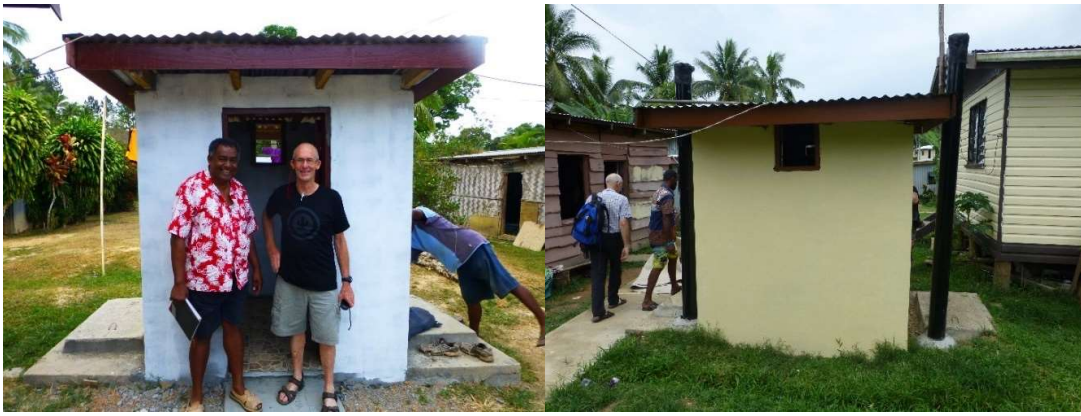
**Figure 2-5:** ecoVIP2 pit latrine tested in Bavu village. During final stages of construction (left) before ventilation pipes fitted, and from back once completed (right) showing ventilation pipes.

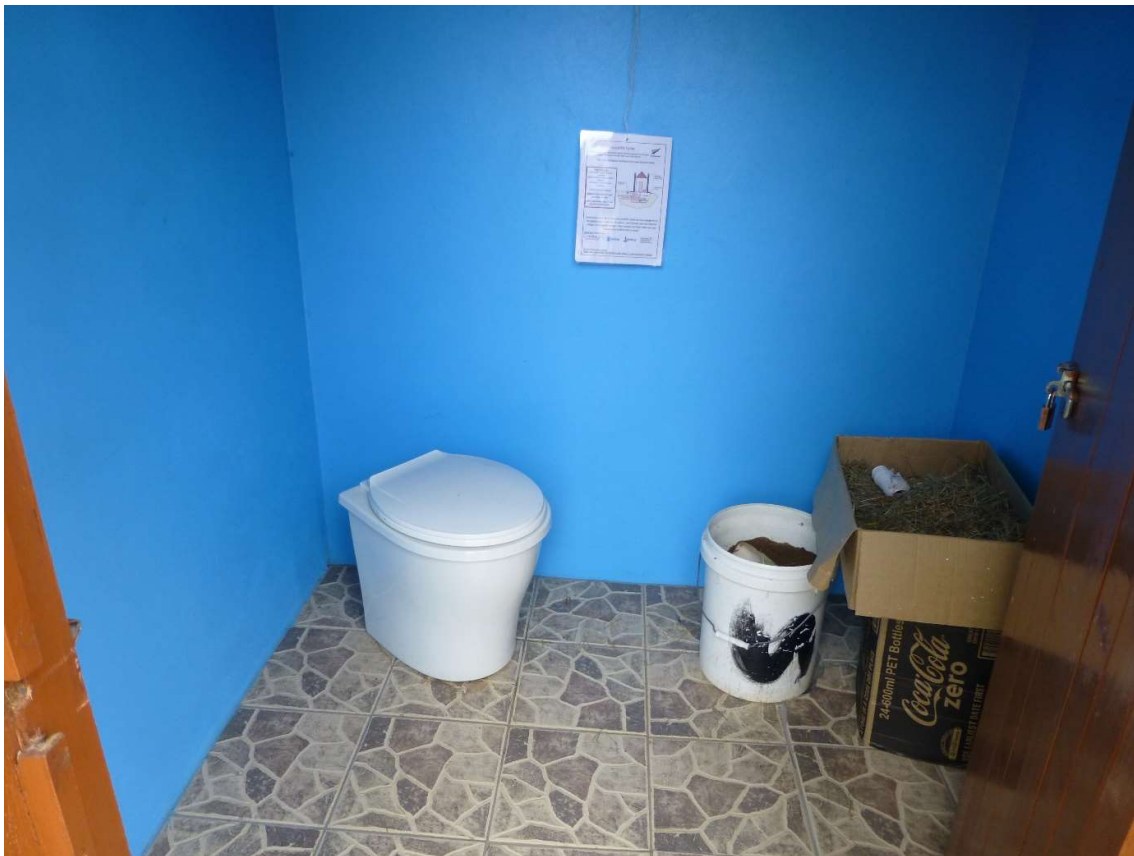
**Figure 2-6:** ecoVIP2 pit latrine interior at Bavu. Note soil and mulch material available to add into the toilet after each use.

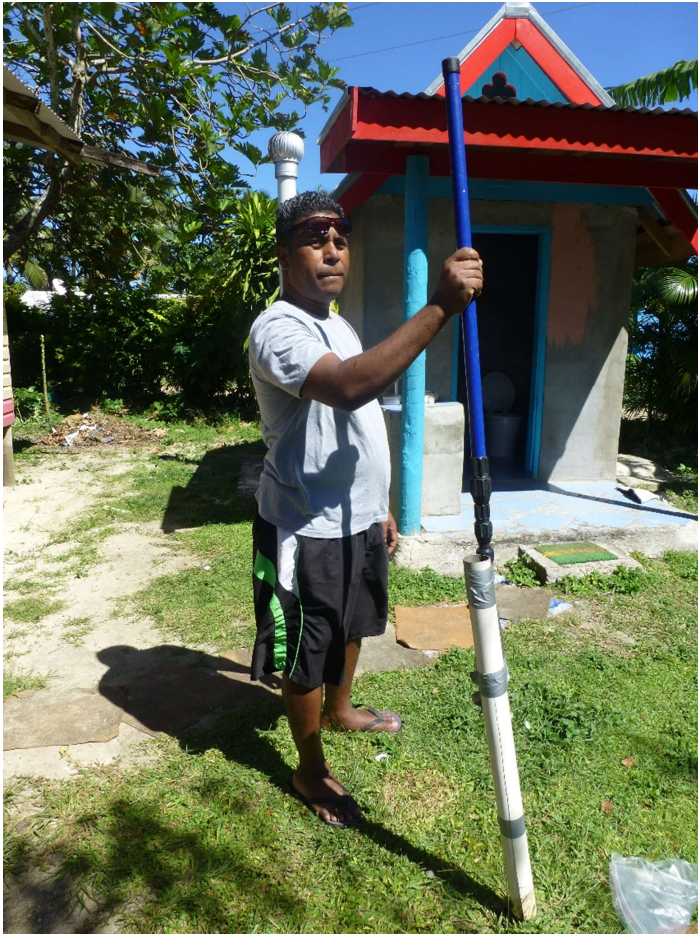
**Figure 2-7: Jeremaia Korojiuta (USP) showing the makeshift sampling tube used to take samples from accumulated faecal wastes in ecoVIP2 toilets.**

collected from the active pit using a section of pipe attached to a long pole (Figure 2-7) and placed in a plastic bag for visual assessment (i.e., colour, texture, smell and presence of invertebrates). The measurements of physical parameters included pH, moisture and ash. The chemical parameters tested included organic carbon and nitrogen and ammonia. The C:N ratio was calculated for each sampling round from a combined sample. Microbiological testing was done for *E. coli*. Techniques were based on APHA (2012) and are briefly described in Table 2-1. Combined humidity and temperature loggers were suspended at the base of the air vents where air exited the pit (representative of within the pit) and under the eaves of the latrine building (representative of outside the pit) at both Namaqumaqua and Bavu. The households using the ecoVIP2 were interviewed each time the pits were sampled and also during general visits to the village to identify any problems or nuisances such as odours or flies.

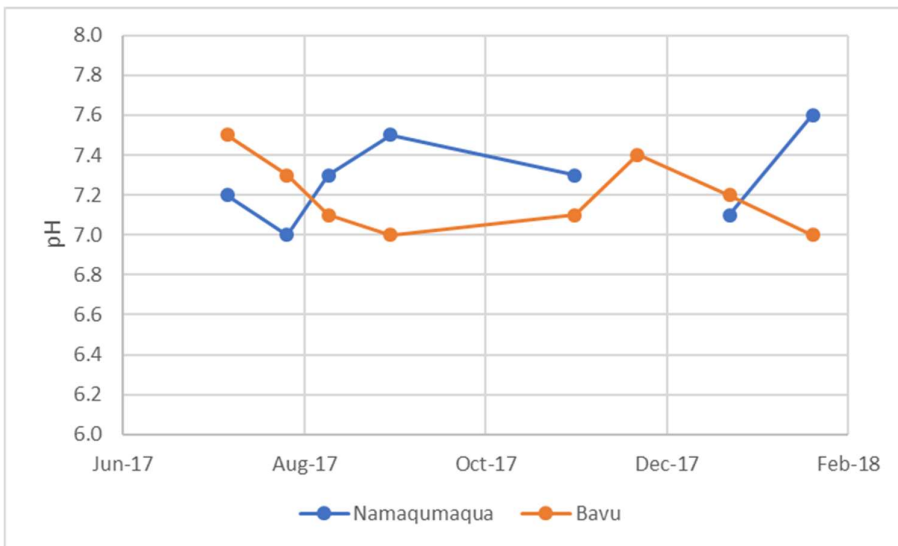
The pH of the piles is shown in Figure 2-13 and ranged between 7.0 and 7.6 at both sites.

**Figure 2-13: pH of the VIP faecal sludge.**

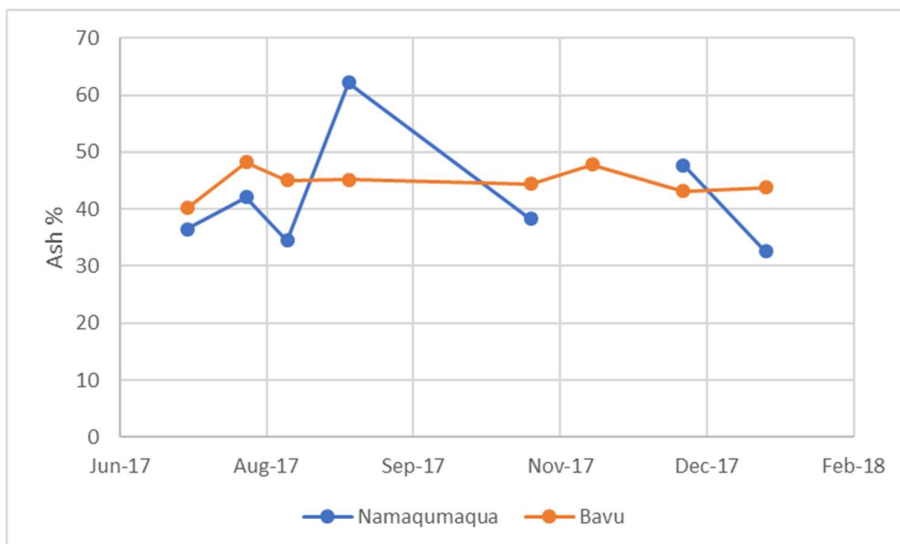
Ash content (as measured by loss on ignition of dried samples) of the pit latrine samples is shown in Figure 2-15. The ash content at Bavu was higher (52-60%) and more stable than at Namaqumaqua (ranging between 37-67%).

**Figure 2-15:** Ash content of the VIP faecal sludge.

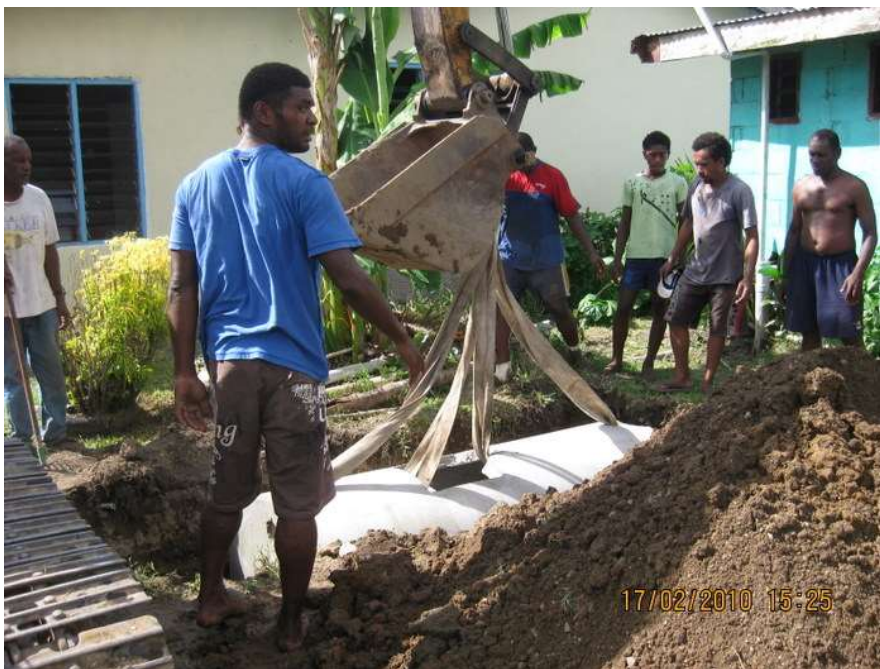
Figure 3-1: New prefabricated septic tanks being installed in Votua village in early 2010.

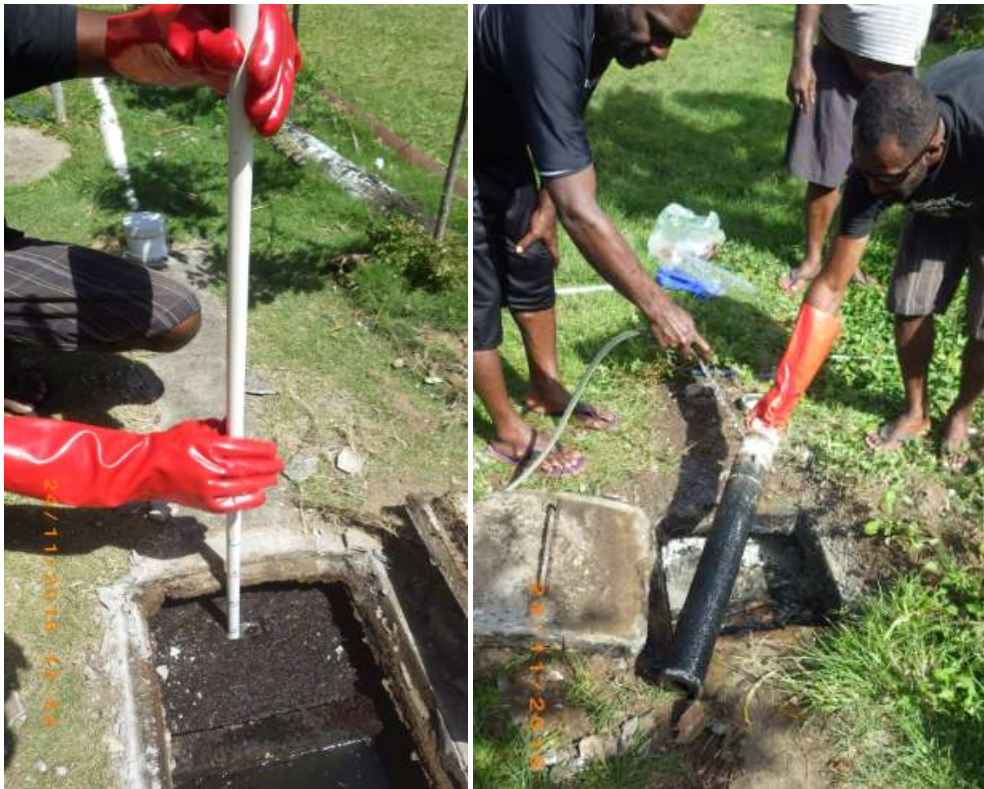
**Figure 3-3: Auditing septic tank sludge accumulation.** Assessing scum and sludge depths (left) and cleaning septic tank outlet filters (right).

New precast, dual-chamber septic tanks installed in Votua village were subsequently measured for sludge accumulation on two occasions, once in 2015 and as part of an audit of a further eight new septic tanks in November 2016. This was about five and six years, respectively, after commissioning. Filters were cleaned, and surface mats and sludge depths were measured in the first chamber of the septic tanks (Figure 3-2; Figure 3-3) as outlined in Dakers 2017c).

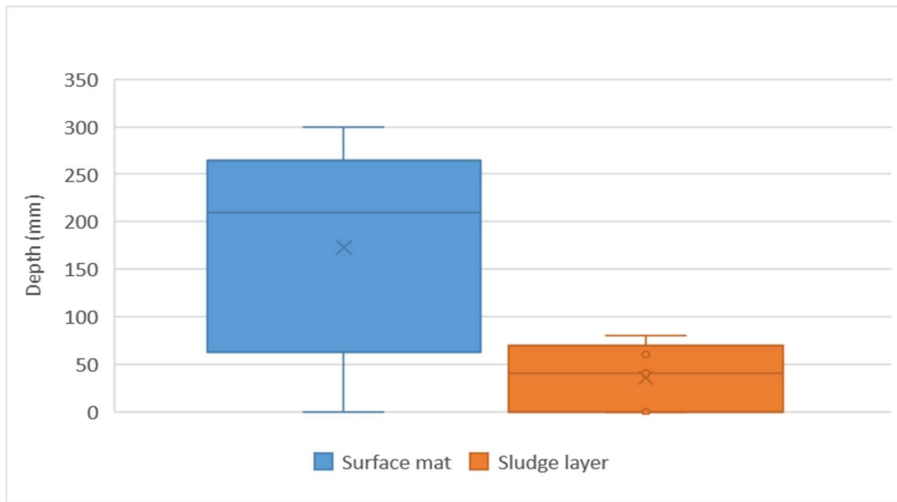
The accumulated depth of the surface mat and the sludge layer measured in the first chamber of the Votua septic tanks is summarised in Figure 3-4. It shows comparatively low rates of sludge accumulation in the bottom of the tanks. The surface scum layer was well developed but not excessive. Negligible sludge or scum accumulation was measured in the second chambers of any of the septic tanks.

**Figure 3-4: Depth of surface mats and sludge layers in septic tanks after 5-6 years operation.** See Appendix A, Figure A-1: Box and whisker graph explanation.

The five new dual chamber septic tanks examined in 2015 after about 5 years’ service all had low levels of scum and sludge accumulation compared to what would be expected in New Zealand. The eight septic tanks examined in 2016 (after about 6 years’ service) showed surface scum depths of 140 to 190 mm (accumulation rate of 35–42 mm yr<sup>-1</sup>) and sludge depths from negligible (2 septic tanks) to 90 mm depth (accumulation rate of 7-8 mm yr<sup>-1</sup>). It was noted that those septic tanks with high dwelling occupancy formed heavy surface scum but very little settled sludge. The moderate scum levels suggest significant fat and oil loads to the septic tanks, and possibly use of inappropriate materials for anal cleansing, such as newspaper or cloths that do not readily disintegrate and sink in the tank.

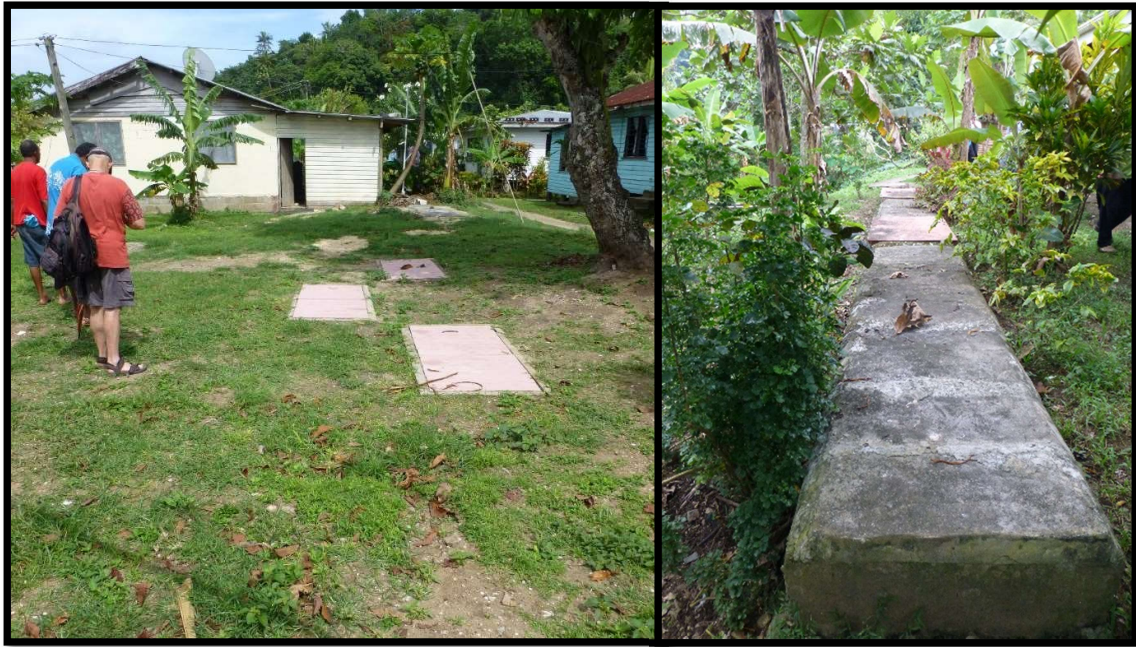
**Figure 4-2: Land application trenches sampled in Namaqumaqua showing inspection hatches.** The House 1 LAS (left) was set into the existing sandy soils on the seaward side of the village, and the House 2 LAS (right) was set in a raised bed above the clay soils and shallow water table on the landward side of the village

The trenches at the clay site were built up above the existing soil (Figure 4-2) and had a perforated drainage pipe set just above the base to drain any excess flow which was not able to infiltrate into the clay soil below. This was piped into a natural wetland area. There was evidence of occasional episodic outflow from this pipe, but never during our sampling or periodic visits. The sides of trenches were lined with concrete block walls and sealed over with a concrete cover to provide an airspace vault above the sand layer. Palm fronds were laid over the surface to form an organic mulch to encourage colonisation by worms and insects.

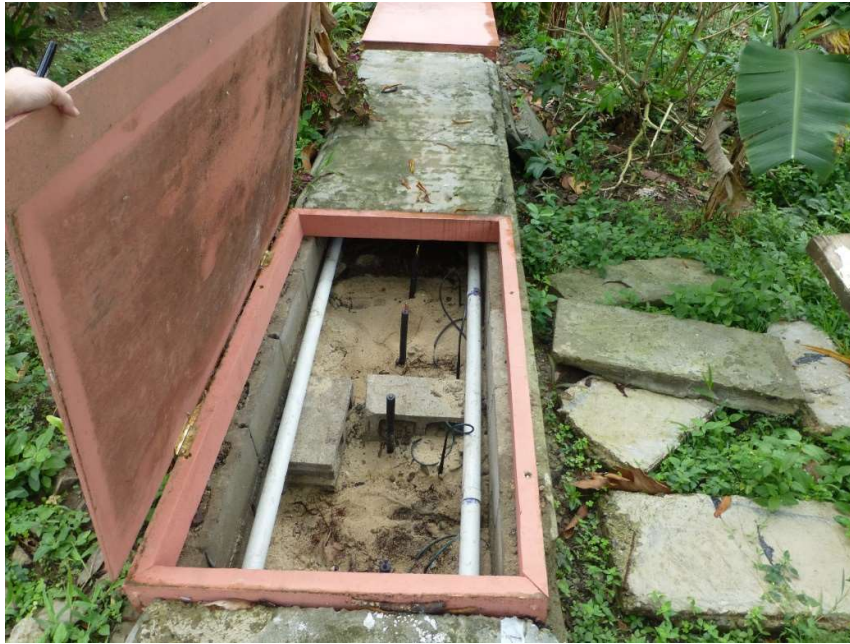
**Figure 4-3: Raised bed LAS sampling point for House 2 clay soil site.** Wastewater dosing distribution pipes (white) pushed to side of trench. Fullstop™ samplers and tubes enabled samples to be drawn from the bottom of the sand filter.

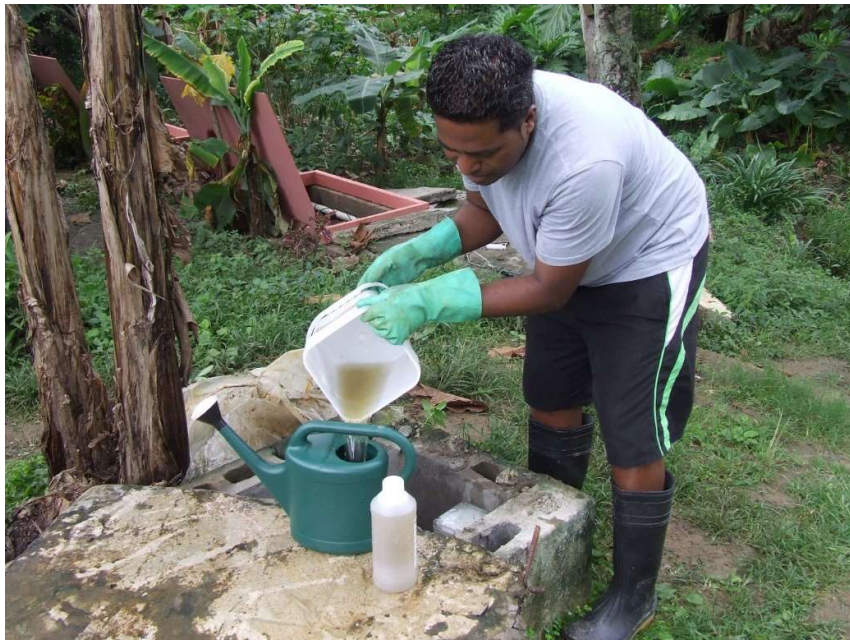
**Figure 4-4: Septic tank effluent being collected from the Flout chamber.** The effluent was then manually sprinkled over a section of the LAS sand filters to simulate a dosing cycle. The filtrate emerging at the base of the sand bed was later collected via the Fullstop™ samplers.

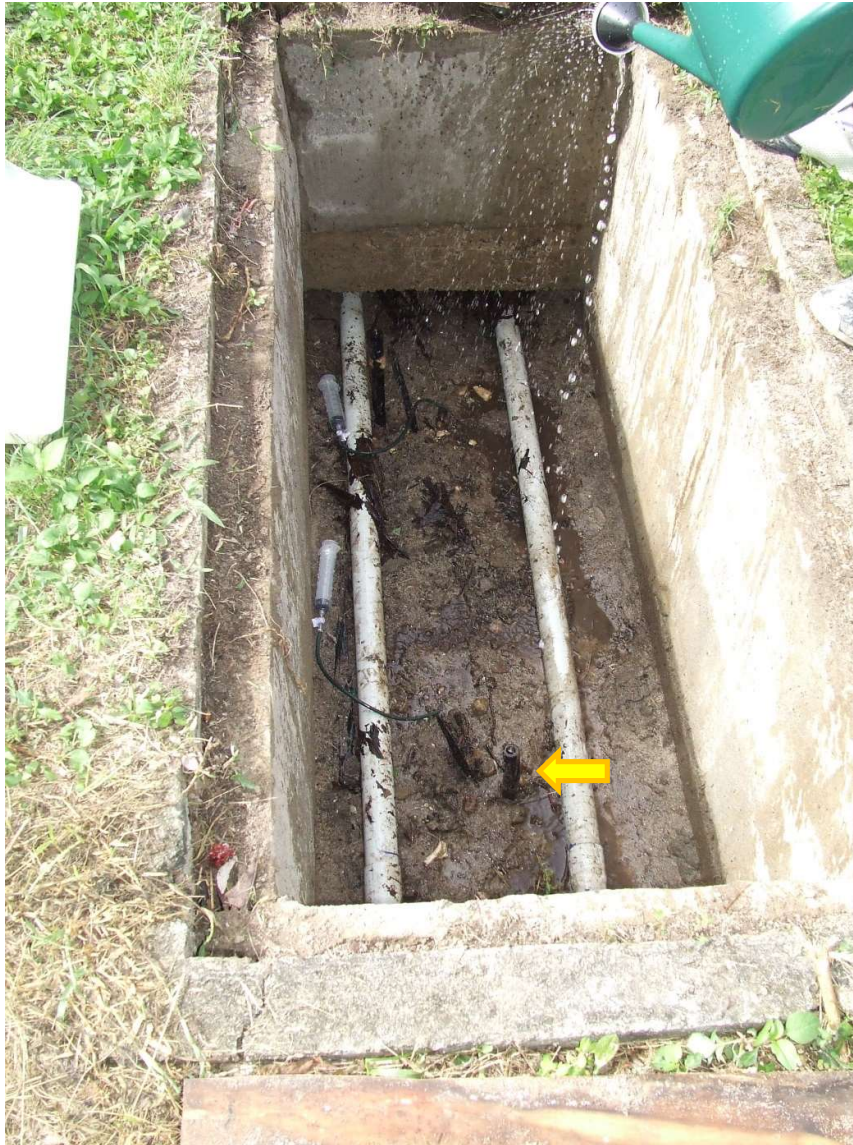
**Figure 4-5: Addition of wastewater during system sampling using a watering can.** Syringes can be seen attached to the FullStop™ sampling devices (arrowed) to enable samples to be drawn from the base of the bed.

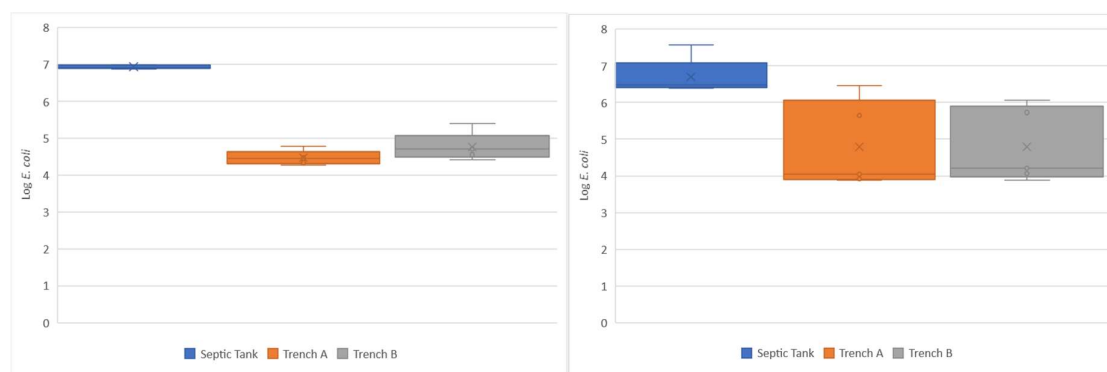
**Figure 4-13: Box and whisker plots of *E. coli* from House 1 (left) and House 2 (right).** See Appendix A, Figure A 1 for explanation of box and whisker graph format.

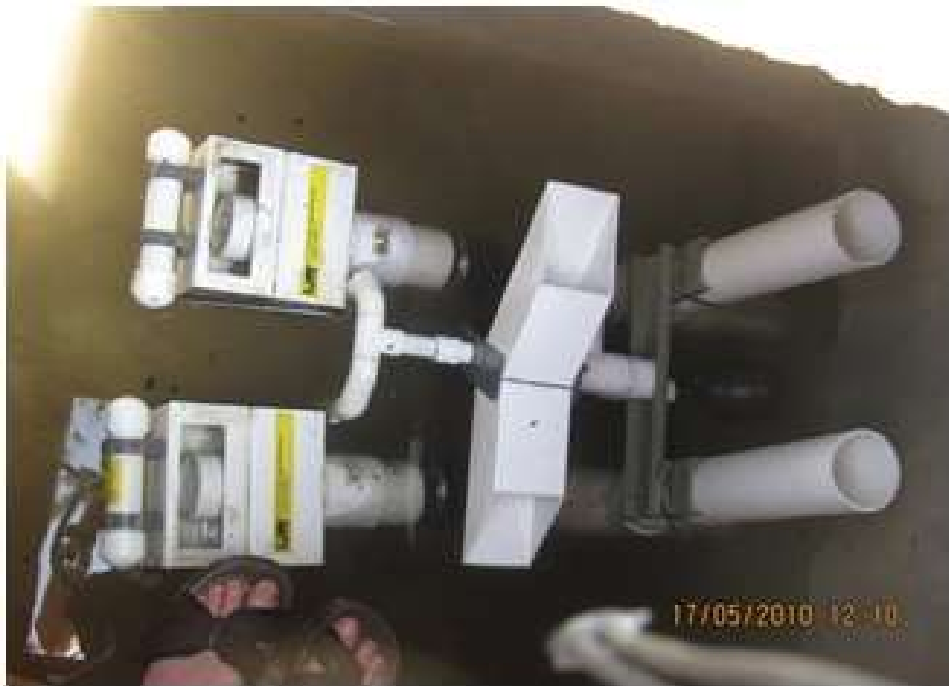
**Figure 5-4: Alternating flouts in VFCW dosing chamber.**

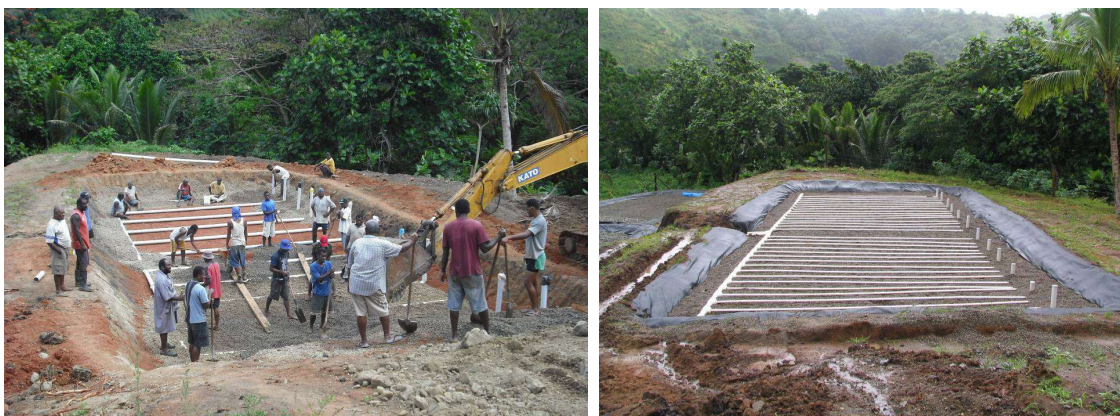
**Figure 5-5: Votua Vertical flow wetland during construction.** The photos show basal drainage pipes being covered in gravel (left) and surface dosing pipes (right).

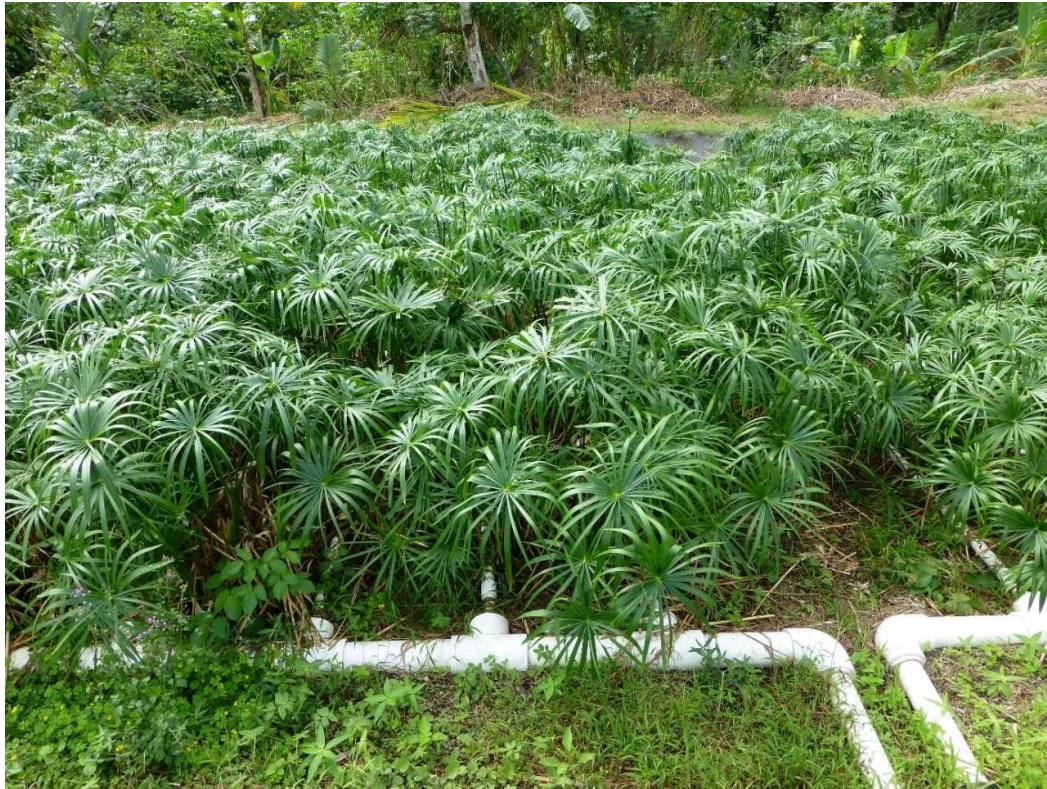
**Figure 5-6:** Vertical flow wetland vegetated with umbrella sedge. Note dosing pipes which disperse the flow across the surface of the wetland.

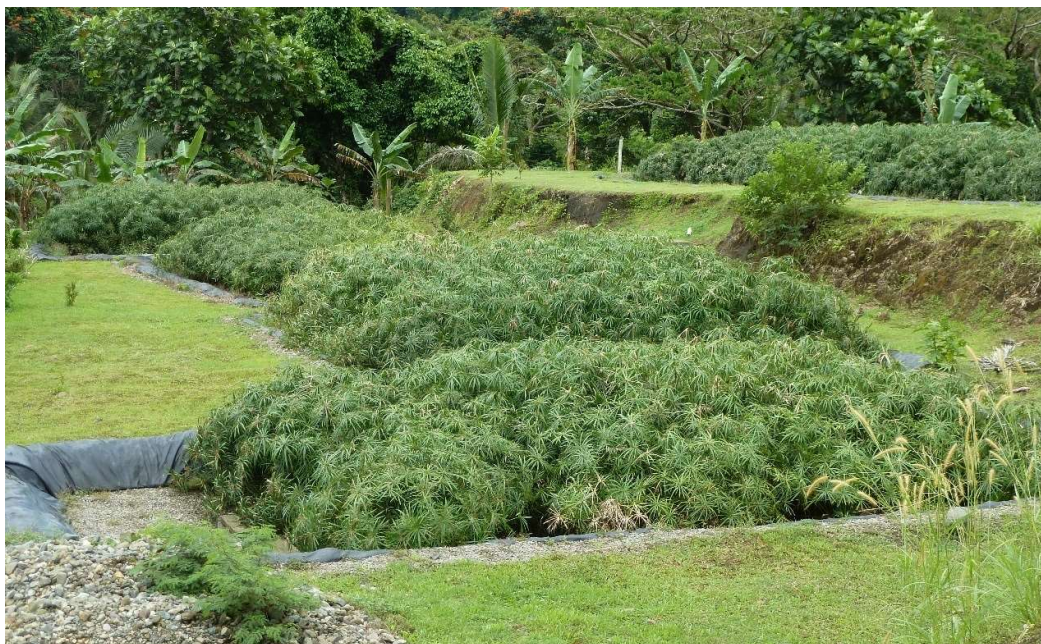
**Figure 5-7:** The four horizontal-flow wetlands (left) and two vertical-flow wetlands (top right) in April 2011.

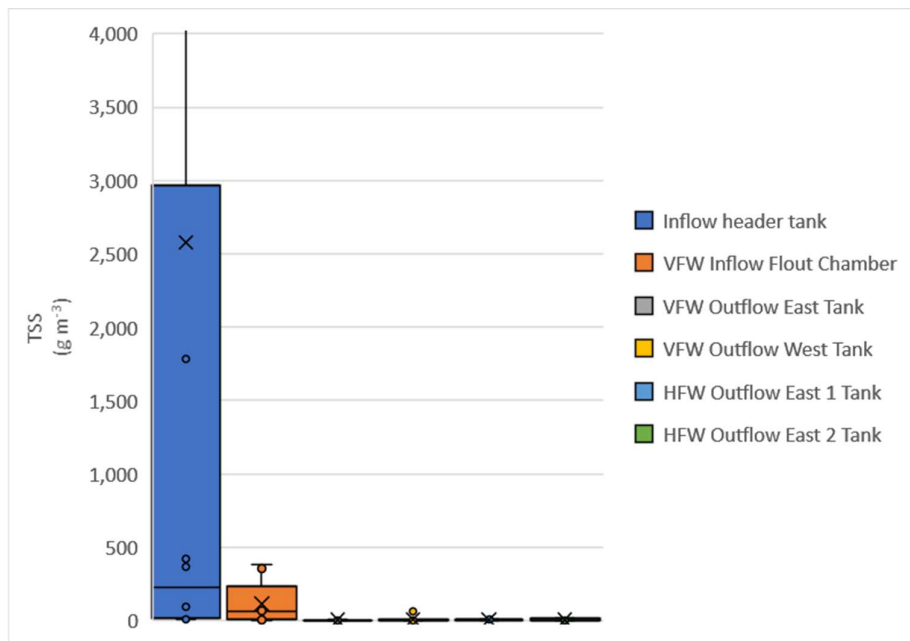
Figure 5-8: Box and whisker plot of total suspended solids in Votua constructed wetland. See Appendix A, Figure A 1 for explanation of box and whisker graph format.

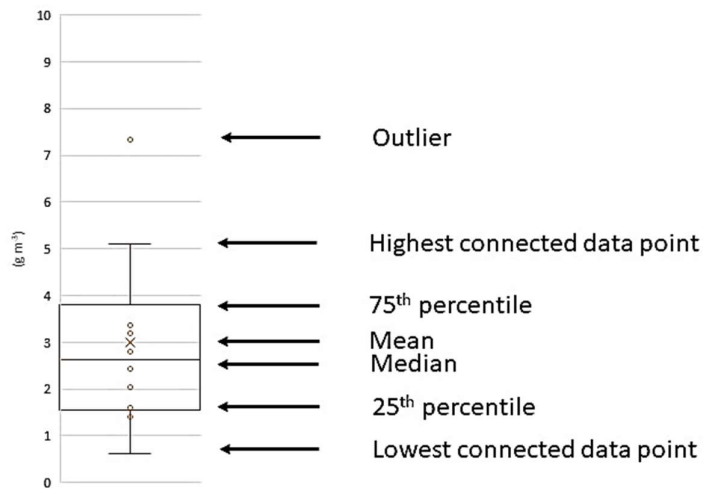
Figure A-1: Box and whisker graph explanation.
