# Status of macrophytes in Lakes Tahaaroa, Numiti and Rotoroa

*Prepared for Tahaaroa Lakes Trust*

*November 2025*

Client Report No: 2025386HN  
Report date: November 2025  
Project No: TKIL2502

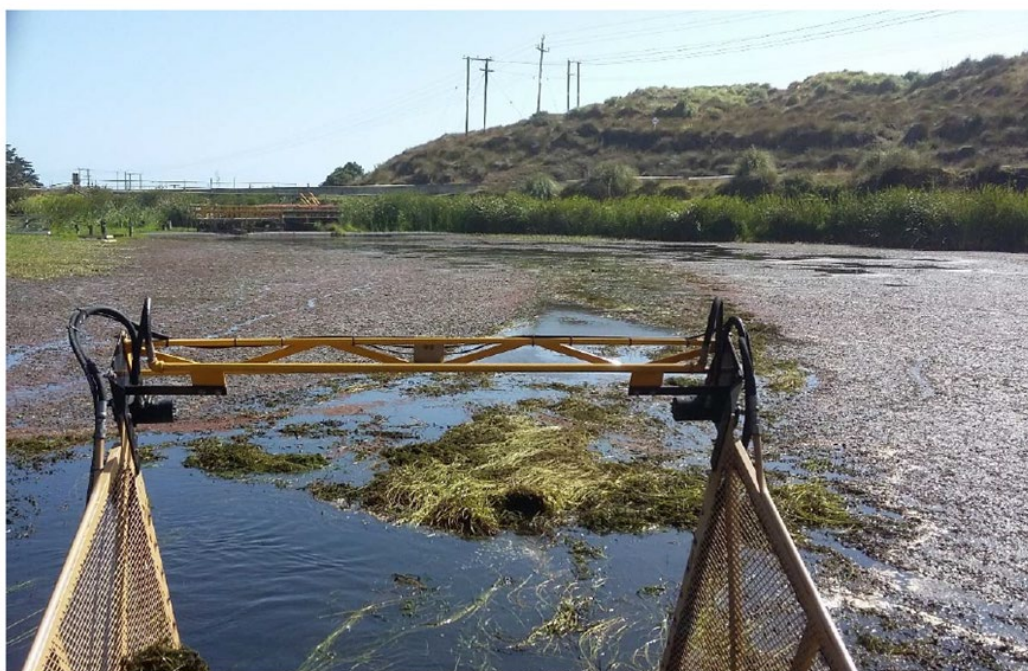
**Figure 15: Bay of Plenty Harvester operating in Wainui Stream outlet to Lake Taharoa for Taharoa Ironsand Ltd, demonstrating potential pathways for the spread of invasive macrophytes such as Hornwort and *Lagarosiphon major* through shared machinery and water movement.** Source <https://atlas.boprc.govt.nz/api/v1/edms/document/A3545264/content> [Photo: Howard Emery]
