# Rotorua Lakes: Plants tell the tale

**John Clayton and Paul Champion**

National Centre for Aquatic Biodiversity and Biosecurity

Presented at "Rotorua Lakes 2003" A Public Symposium on Practical Management for Good Lake Water Quality.

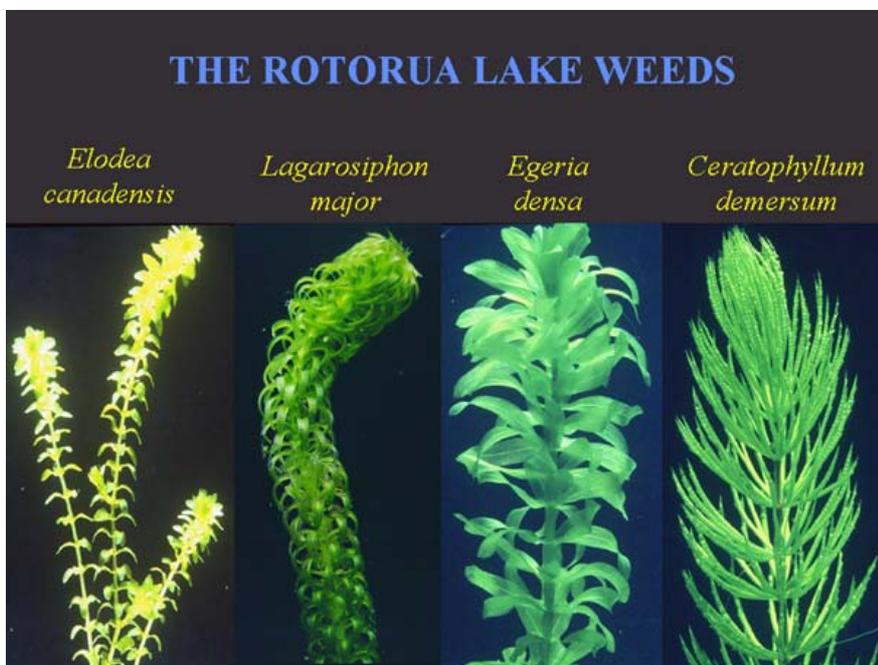
Figure 3. Problematic submerged weeds (increasing weed impact from left to right).

Wildlife is not a factor in the spread of problematic weed species. Wildlife can only spread weed through consumption and transport of plant seeds in the gut, but none of the problematic submerged weed species produce seed in New Zealand. All of the nuisance weed species reproduce vegetatively and their spread is from movement of vegetative fragments. The key vector in movement of weed fragments is people; either through deliberate (e.g. ornamental ponds, release of aquarium contents) or accidental spread (e.g., contaminated boats, trailers and nets). This clearly demonstrates the benefits of isolation and explains the close association between lake access in the form of boat ramps and the incidence of introduced weed species in lakes (Johnstone et al. 1985). Lake Rotomahana is dominated by native species, while the remaining group of “best” lakes (Rotoma, Okataina and Tikitapu) have not been affected by the worst invasive weed species to date (Figure 3).

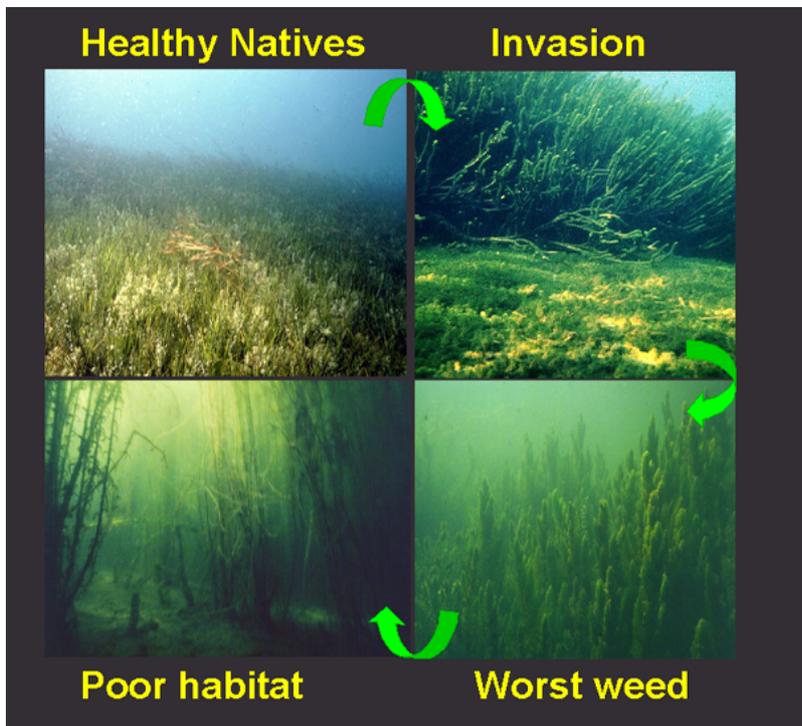
Figure 8. Increasing impacts of weed invasion.

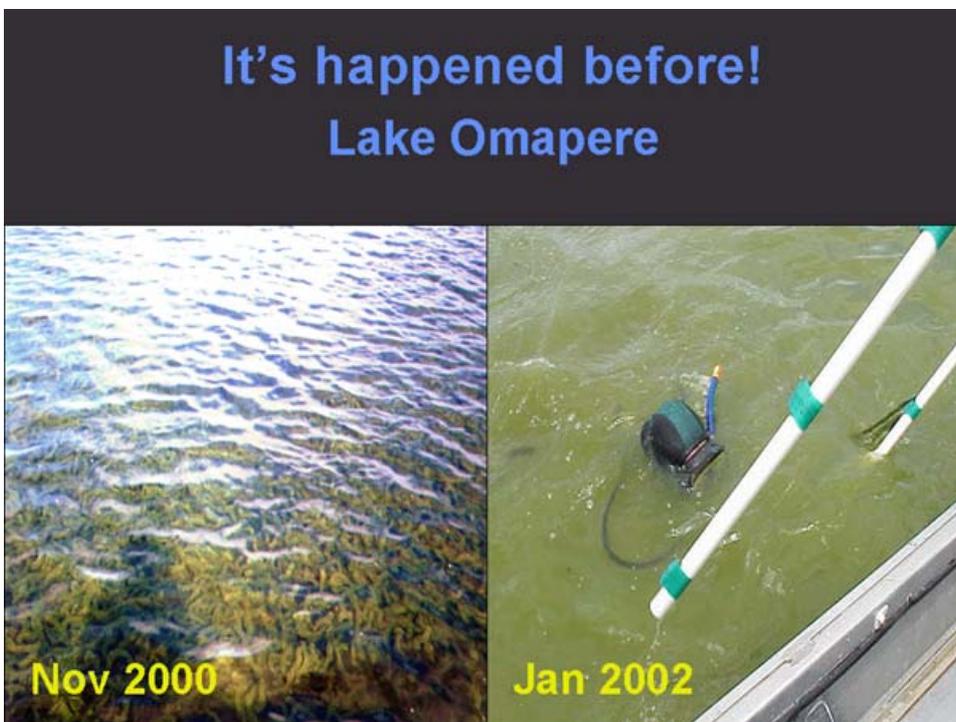
Figure 10. Lake Omapere pre and post vegetation collapse.
